Flood Risk from Dams

TA 9634 Work with IWUMD in Myanmar

TA 9634-REG: Strengthening Integrated
Flood Risk Management

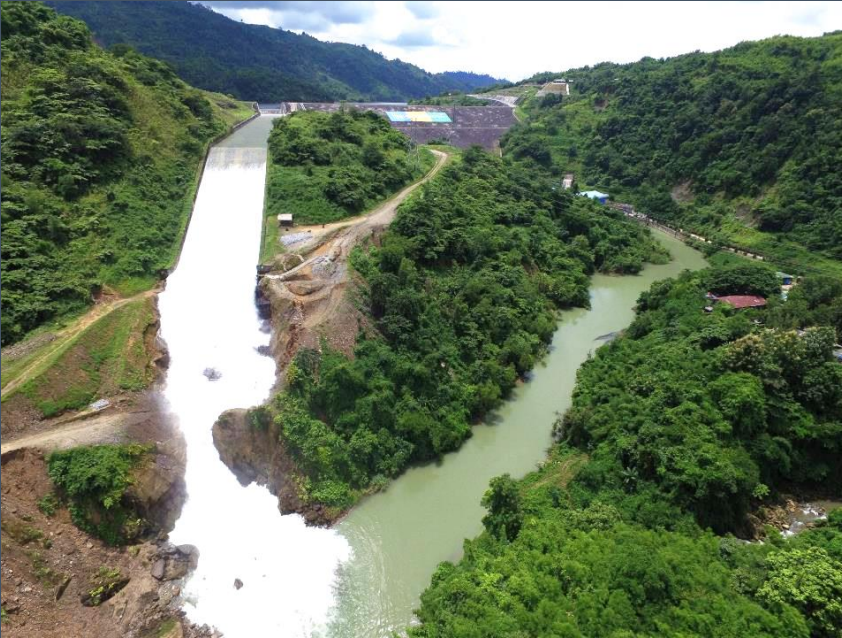
Phyu Dam

- Bucket Spillway damaged
- Repaired using gabion but re-eroded
- Outlet valve vibration issue and hydropower outage -> more pressure on spillway
- <https://www.youtube.com/watch?v=4yOXpSxyWN>
U

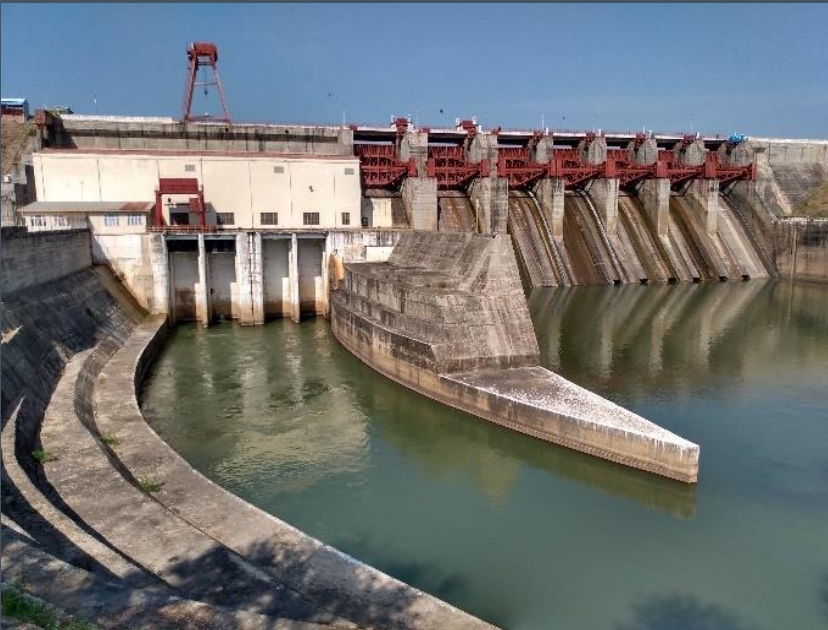
Sedagwi

- Operations
- Downstream flood
- Gate malfunction

- Multipurpose
 - Irrigation
 - Hydropower
 - Potential flood alleviation
- $H=40.5\text{m}$
- $C=447\text{MCM}$,
- Completion 1987, ADB Funded

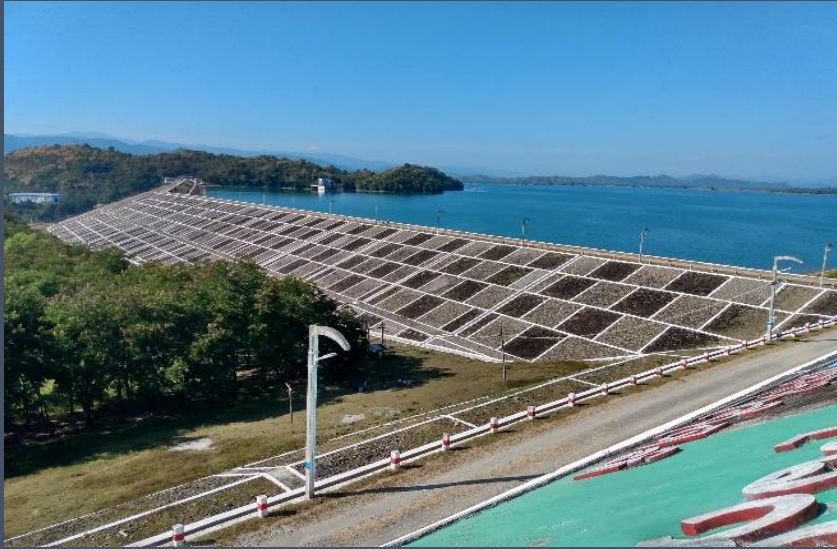
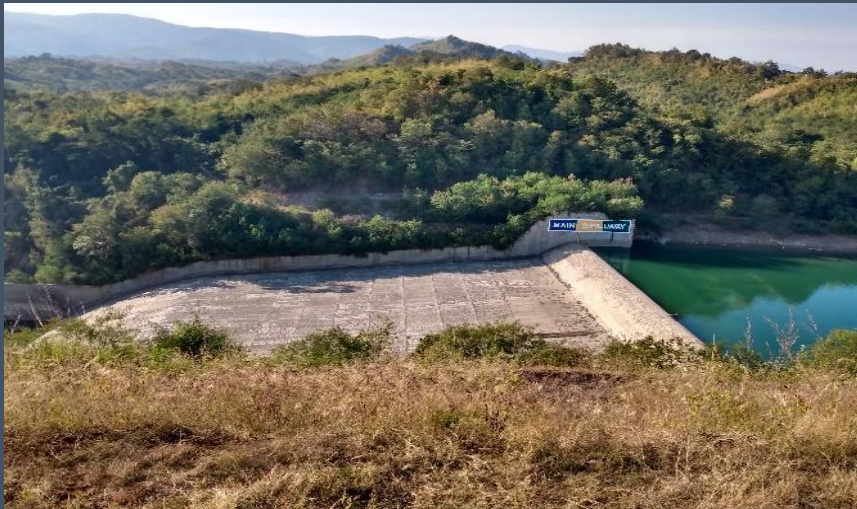
Mone Dam

- Irrigation and Hydropower
- Spillway capacity exceeded and damaged, weir remained in tank despite some bypass
- Additional drop structures on spillway channel damaged
- New Auxiliary spillway under construction

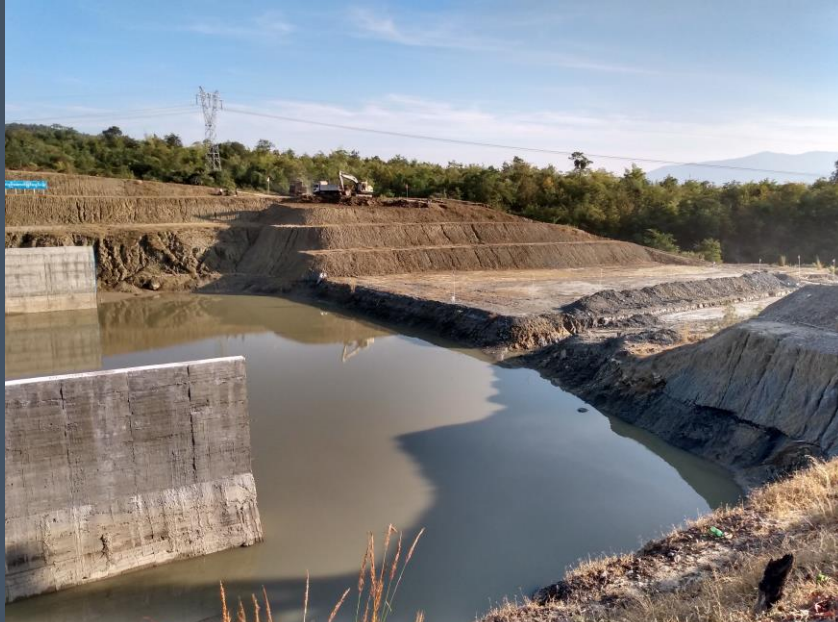
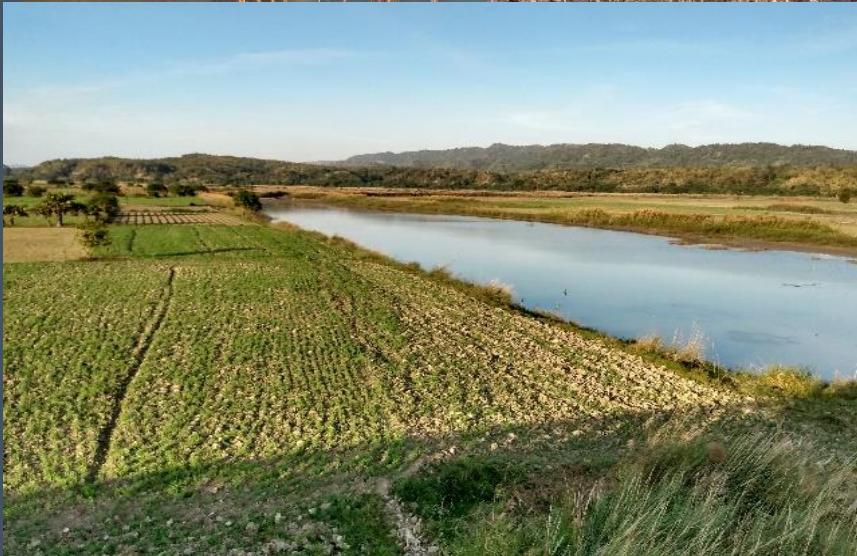
Mone Dam

- Irrigation and Hydropower
- Spillway capacity exceeded and damaged, weir remained intact despite some bypass
- Additional drop structures on spillway channel damaged
- New Auxiliary spillway under construction

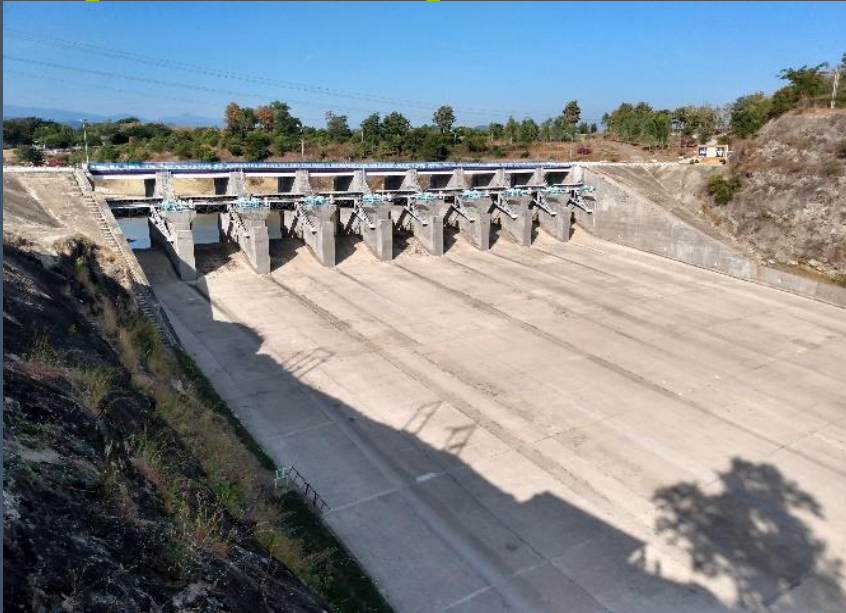
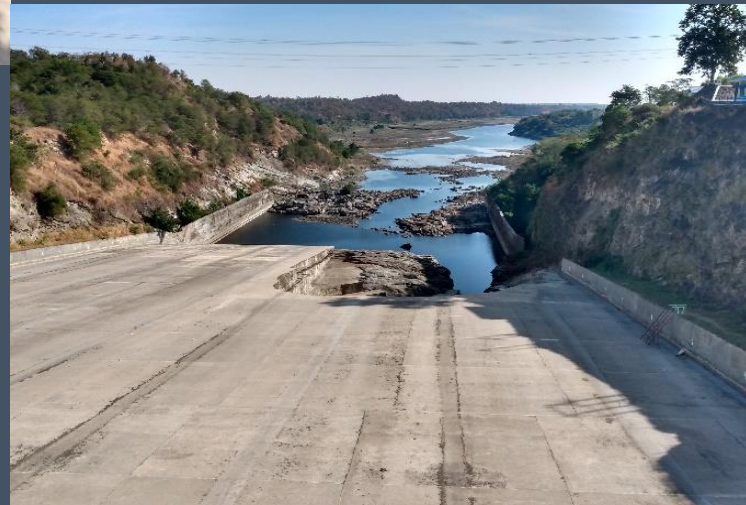
Kyee-on Kyee-wa

- Spillway capacity
- Erosion
- Gates create backwater downstream of Mone
