Condition Assessment Examples

Use *IPWEA Condition Assessment & Asset Performance Guidelines: Practice Note 7* to assess and assign condition grading to the following asset examples. Table extract from the Practice Note has been provided.

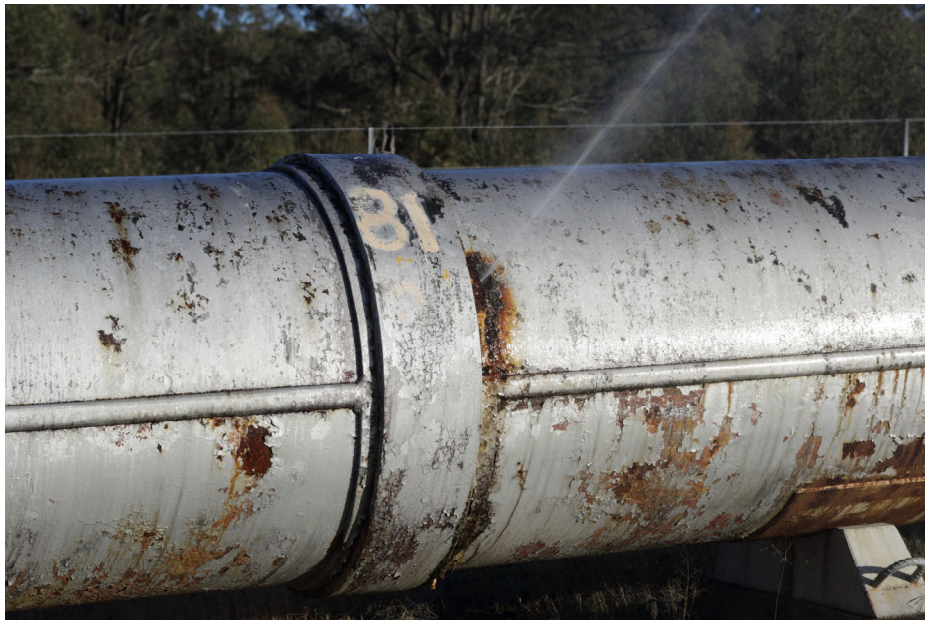
Pipework: Condition 2 – Acceptable physical condition but showing minor wear. No longer in new condition, minor corrosion present on flange, but remains functionally sound.

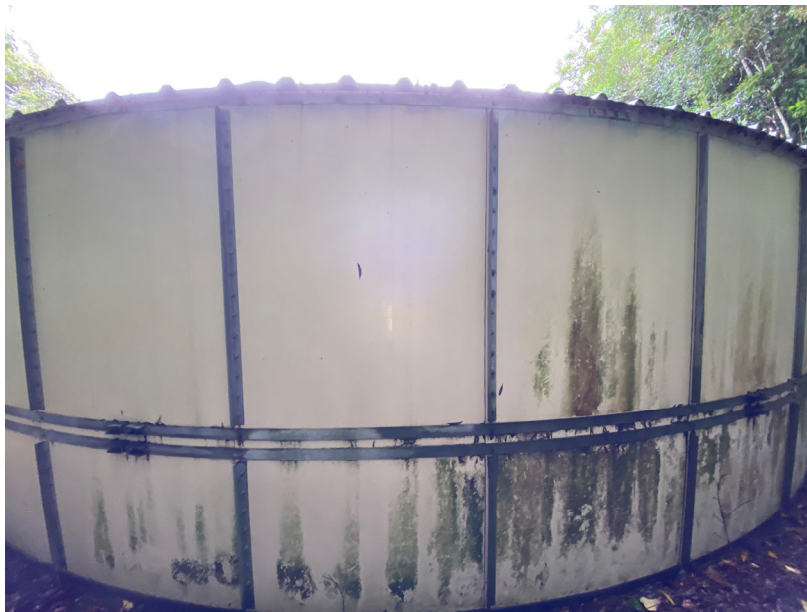
Unsure what this is: Condition 4 – External corrosion present. Still functions but will need replacement in the near future.

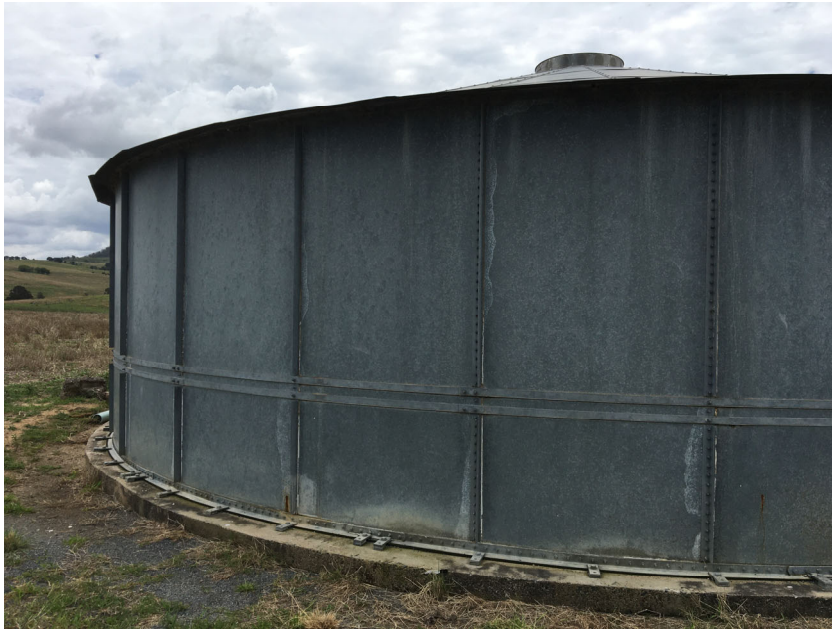
Reservoir: Condition 2 – Minor deterioration, sound physical condition.

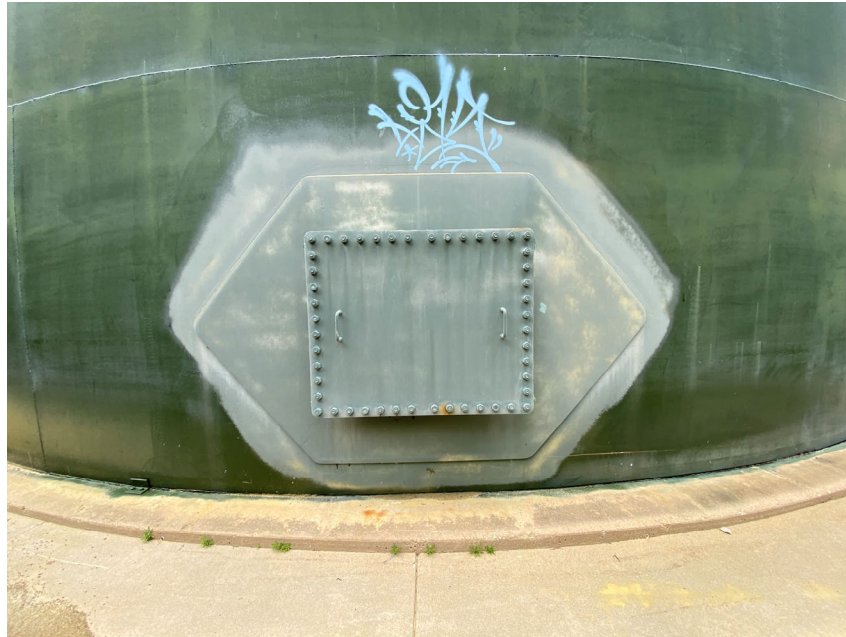
Reservoir: Condition 5 – Evidence of leakage

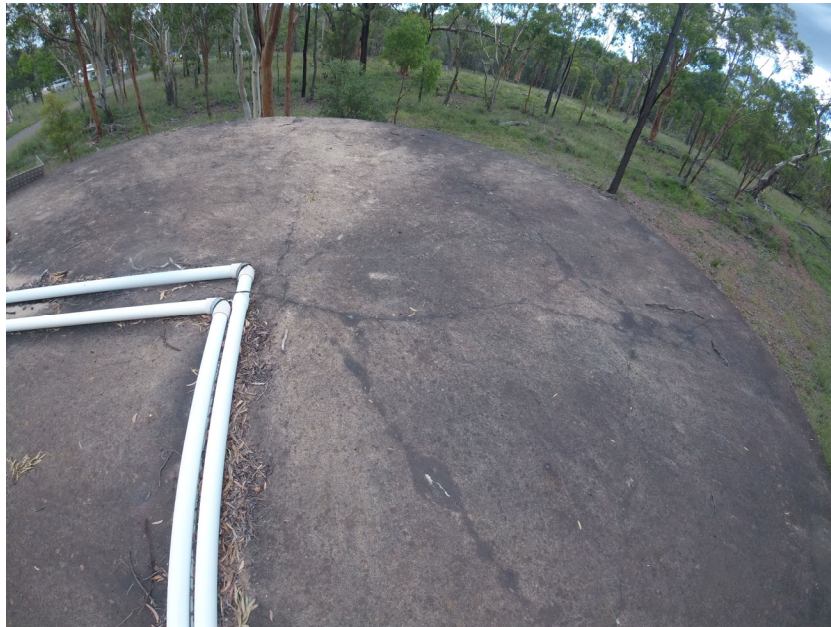
Structure: Condition 1 – Near new condition. No defects.

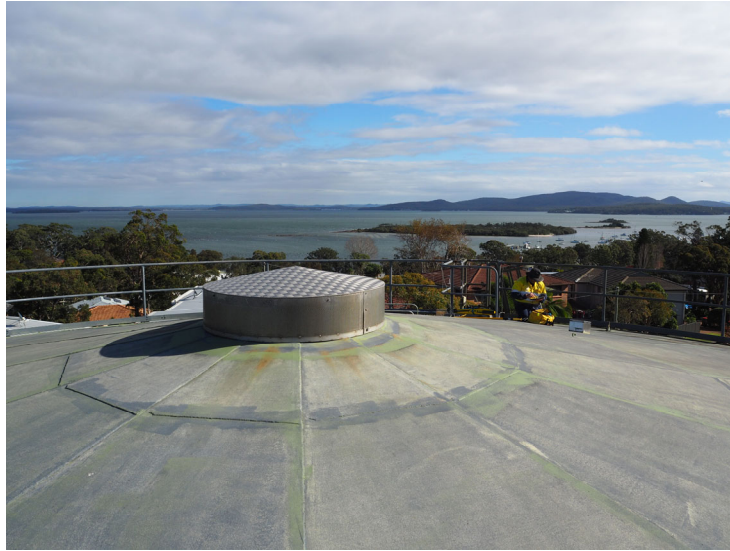
Reservoir roof: Condition 3 – Moderate degradation present, minor cracking with no leakage evident, pipes appear in good condition with no leakage or breakage.
