Renovation of Shihmen Reservoir for Sustainability

Paul S.T. Hsu Ph. D., PE

2017.06

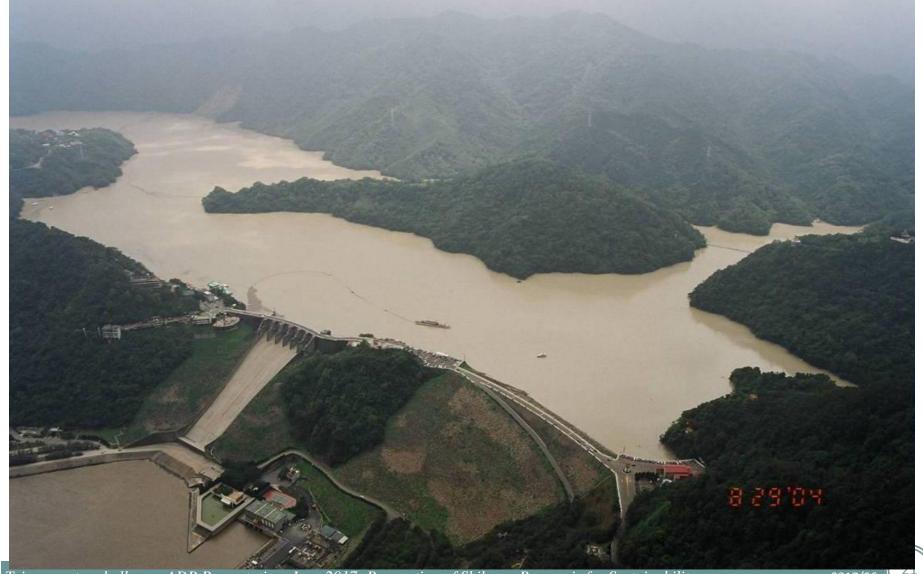
View of Turbid Reservoir After the Storm

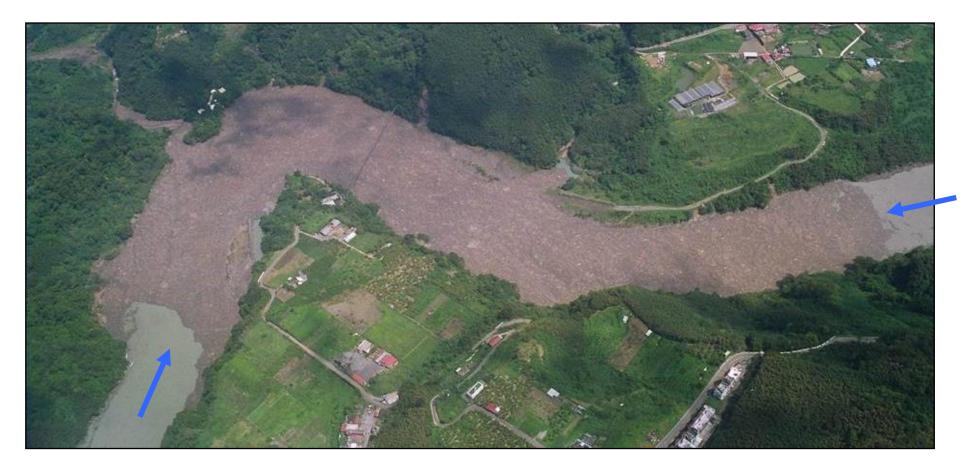
View of Log Accumulation in Upstream Reach

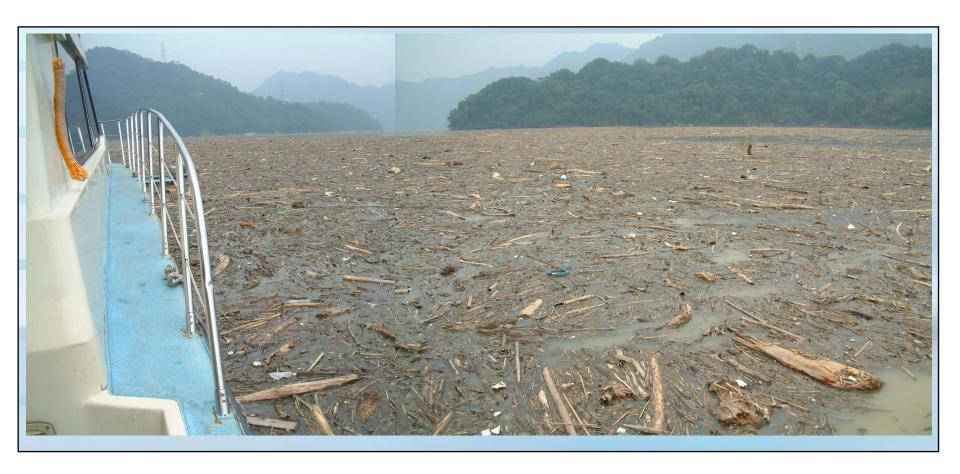
View of Floating Debris in the Reservoir

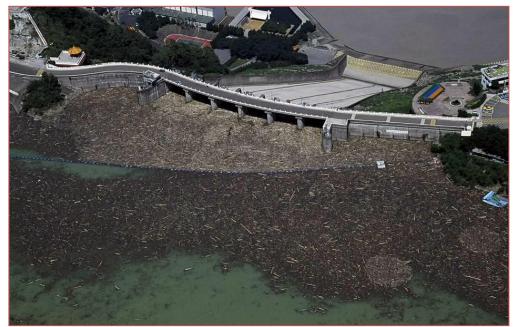
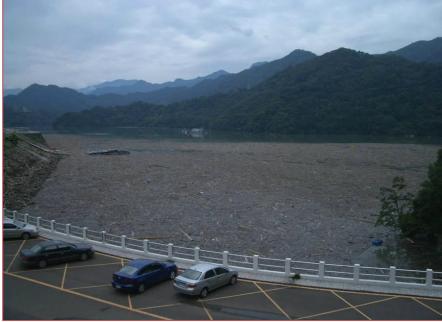
View of Log Accumulation Near the Dam

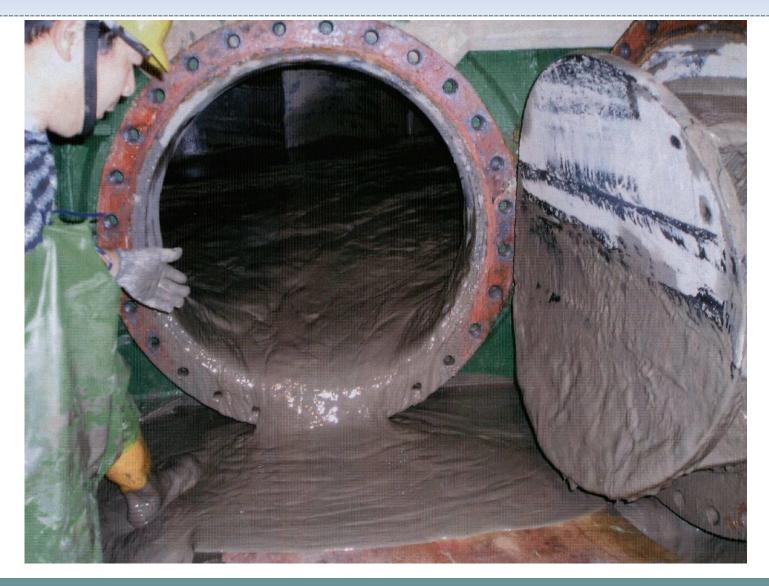
Mudflow in Penstock

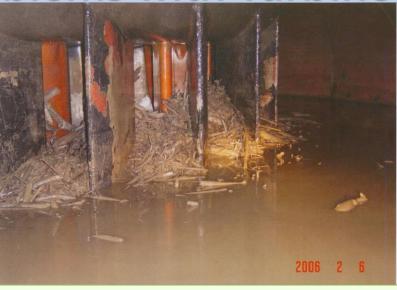
Problems with Turbine & Valve

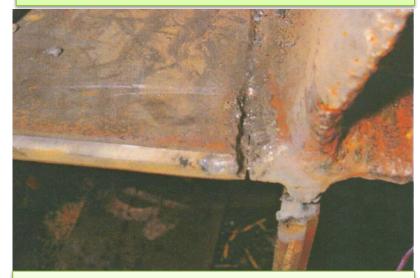
Guide Vane

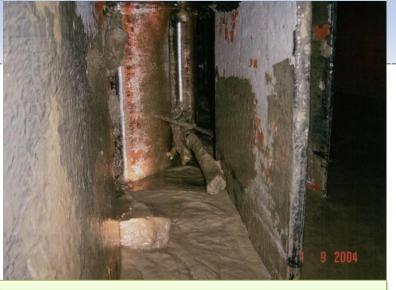
PRO Damage

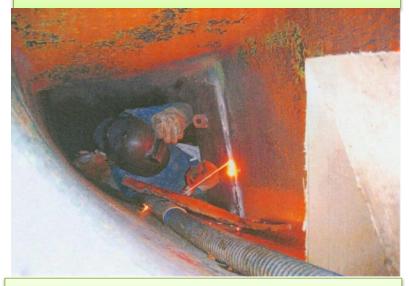
Wicket Gate

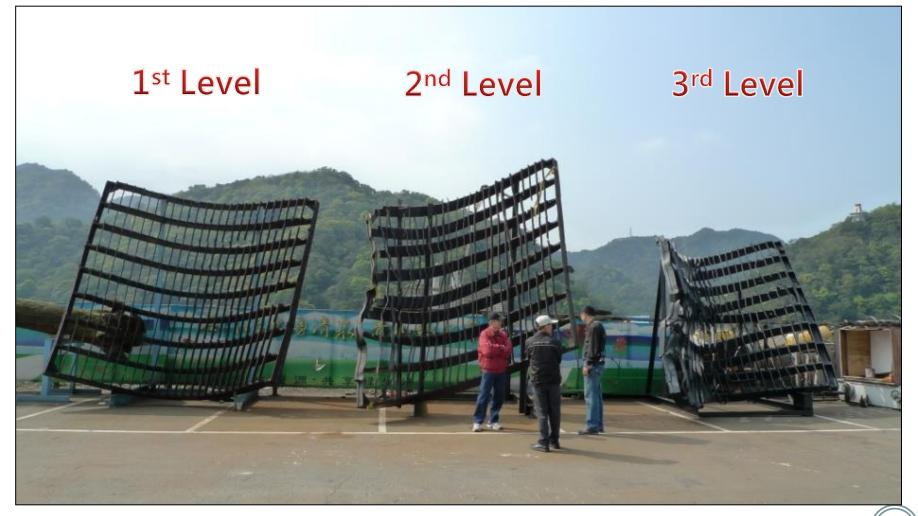
PRO Trashrack Damages Caused by Log/Mud Blockage
