Flood Risk from Dams

TA 9634 Work with IWUMD in Myanmar

TA 9634-REG: Strengthening Integrated
Flood Risk Management

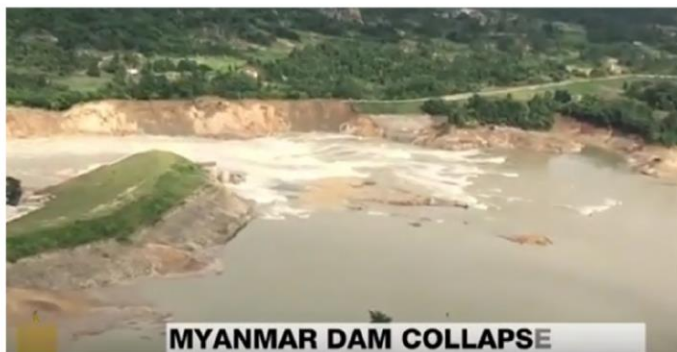
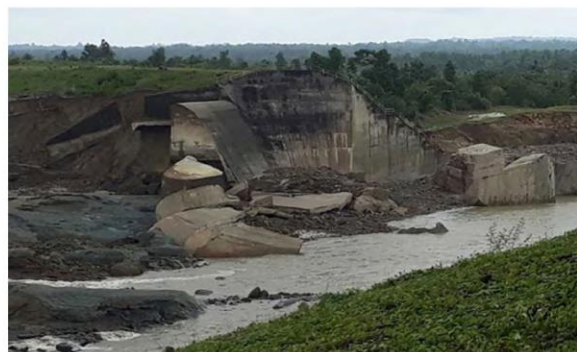
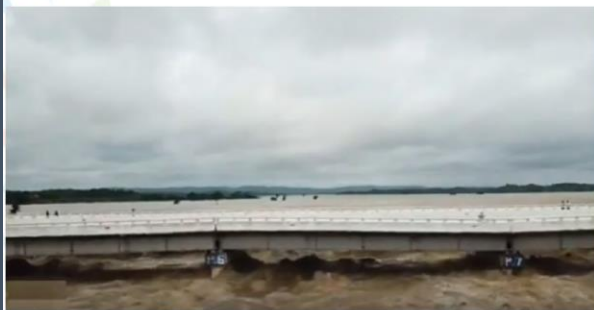
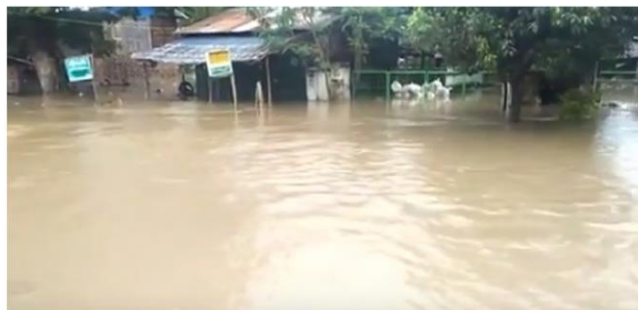
✓ Swar Chaung Dam:

- H=29.6m, L=2011.7m, Storage=281MCM, Earth-Fill, Constructed in 2002
- World Bank will rehabilitate this dam.

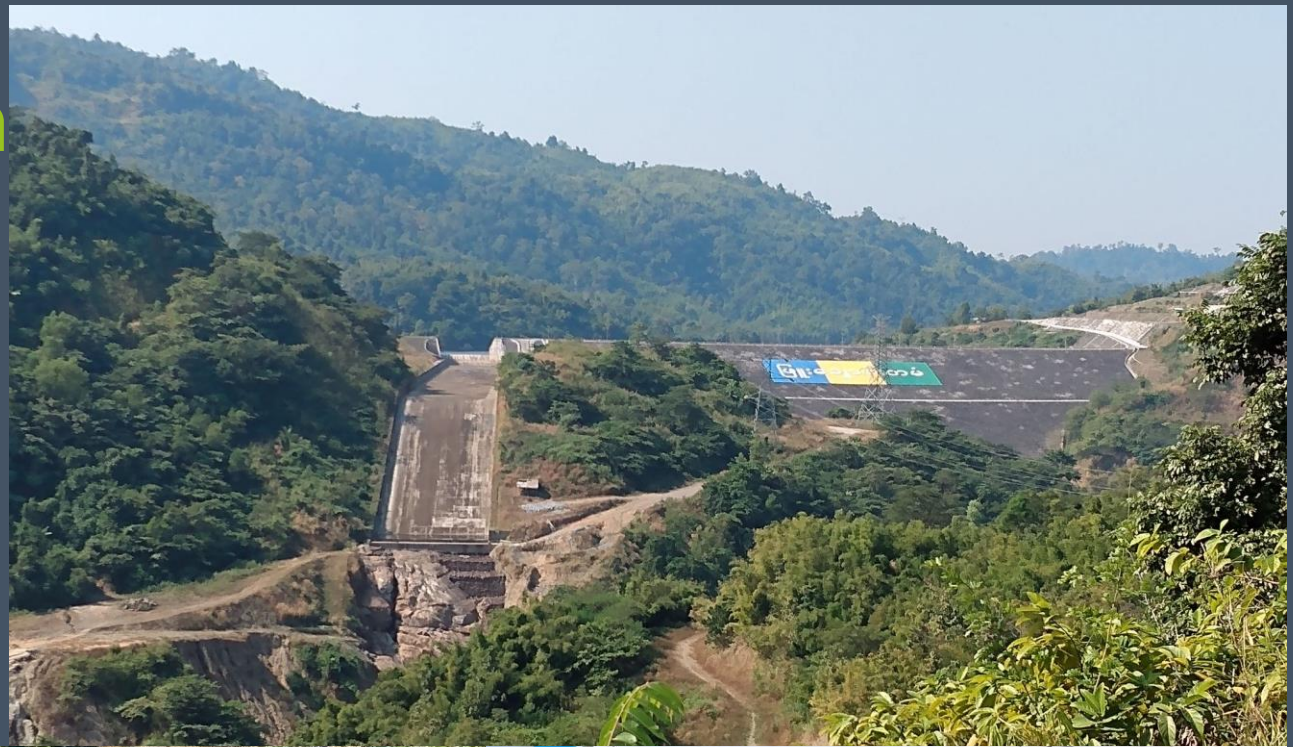
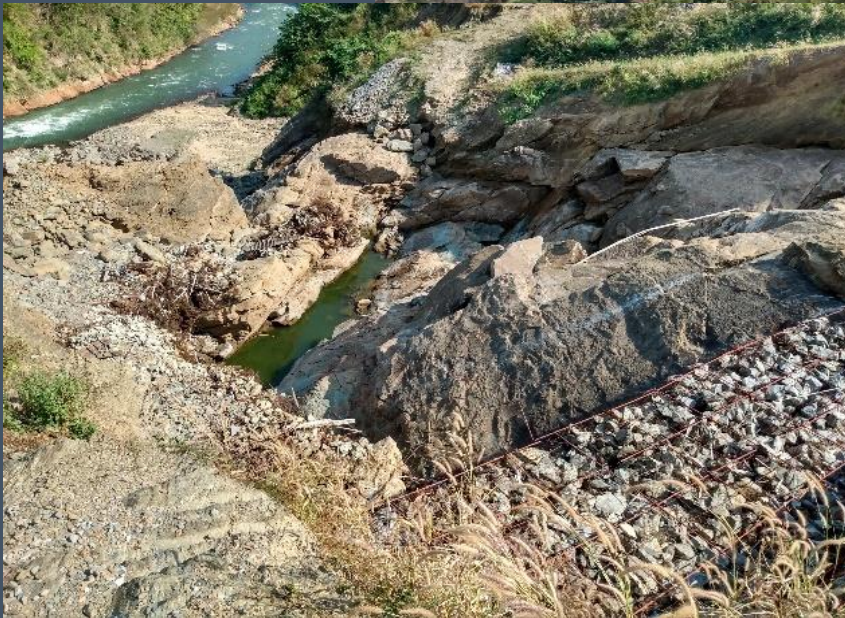
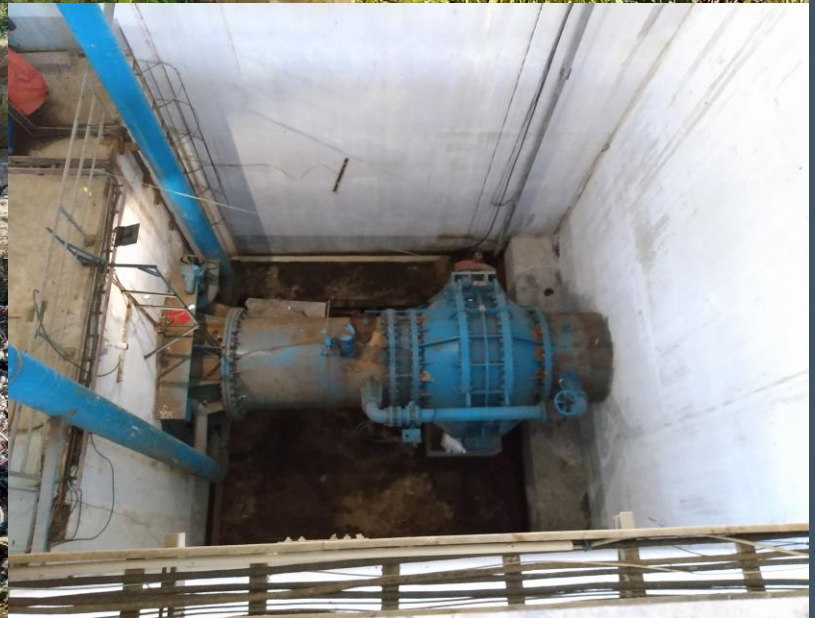
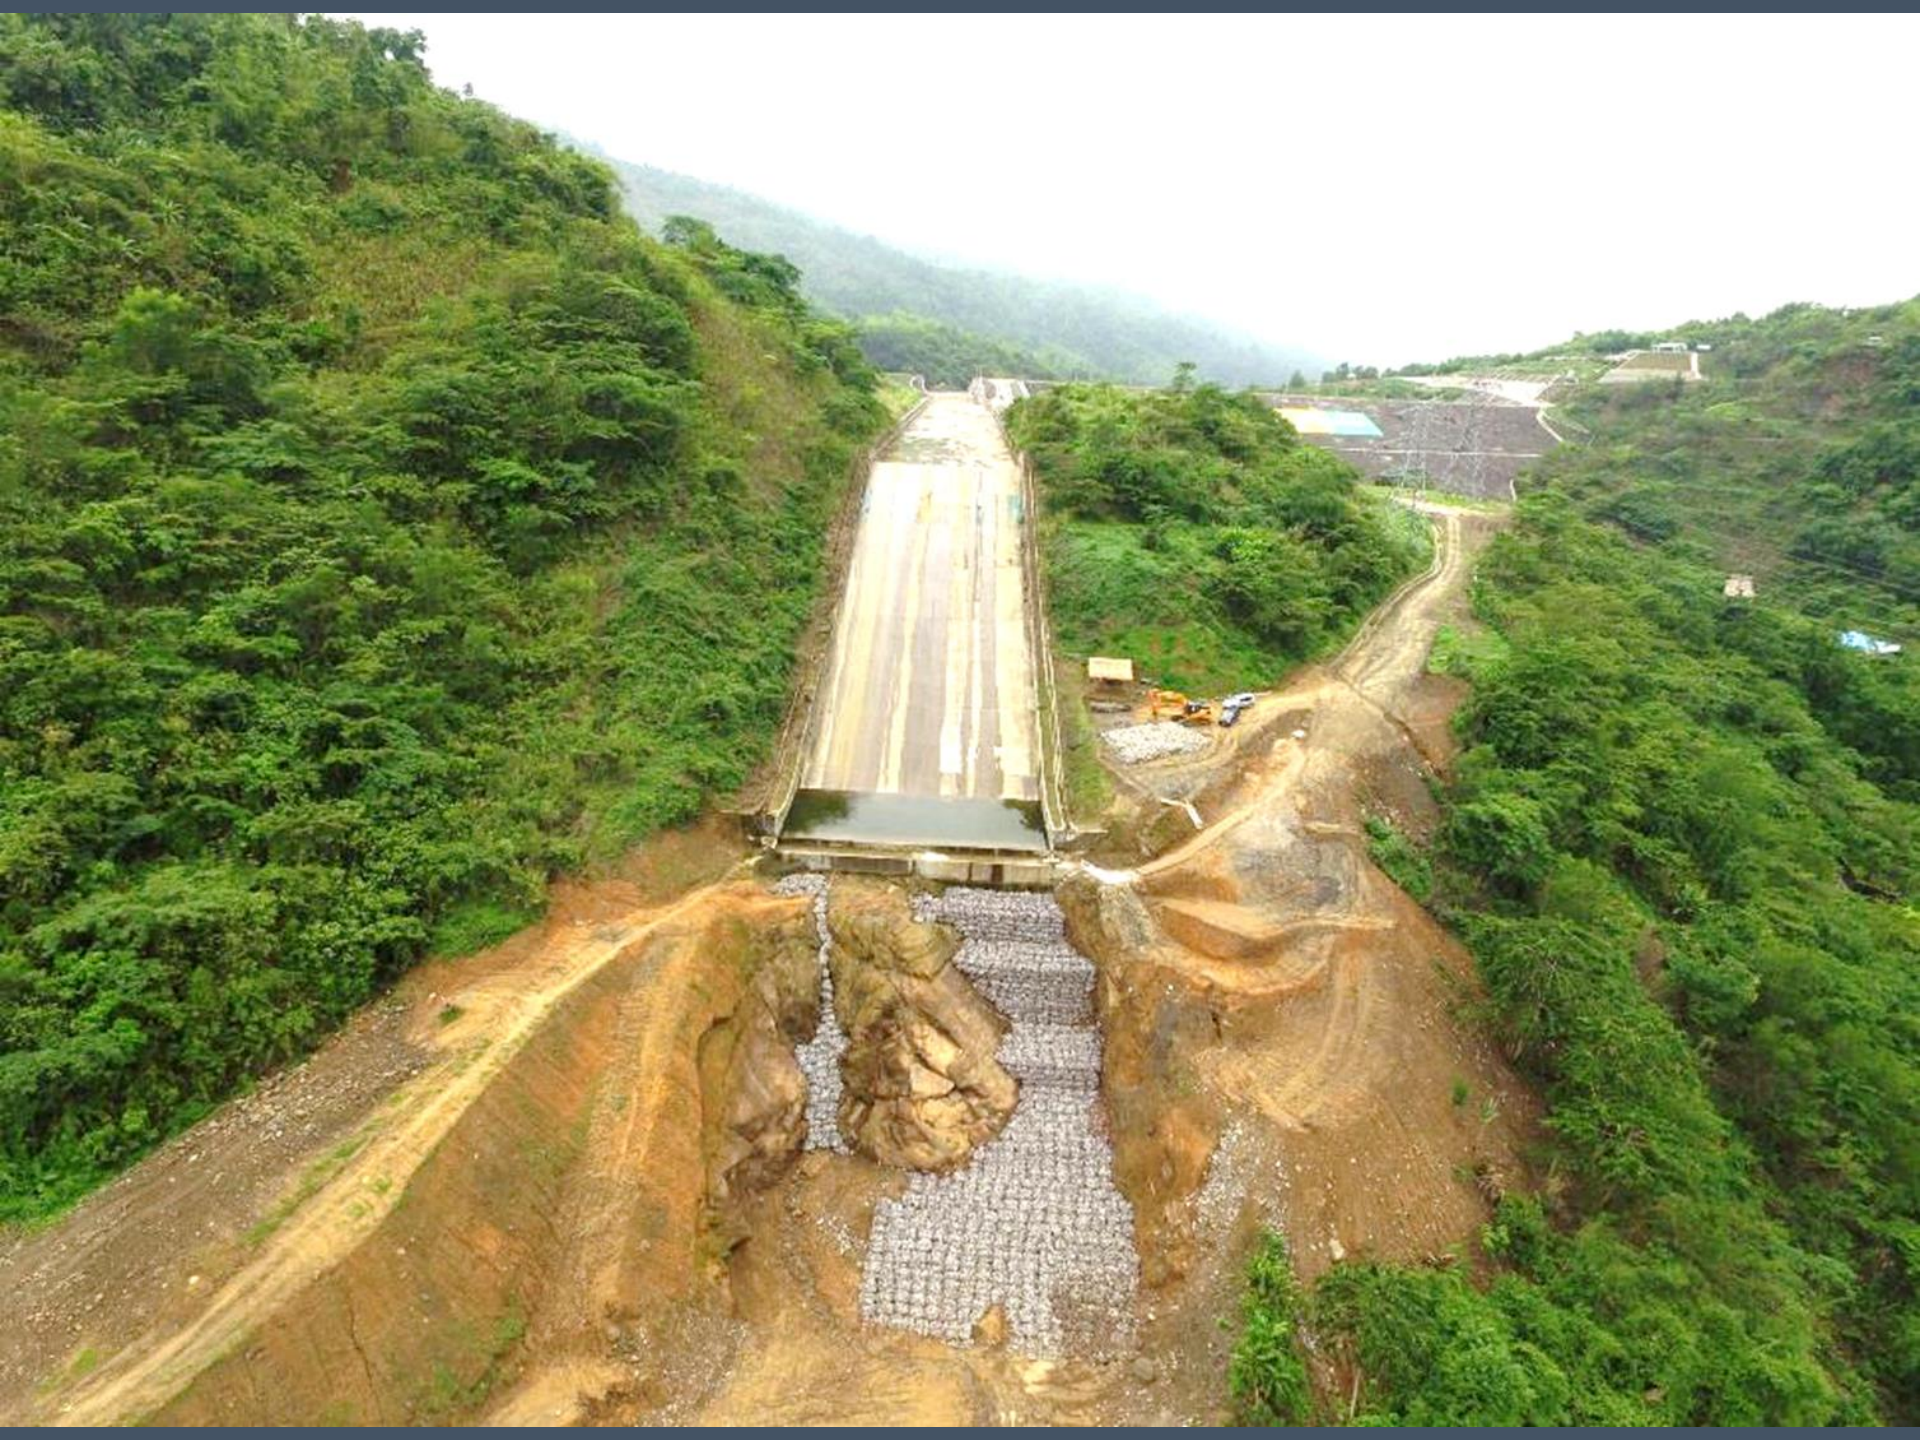
Phyu Dam

- Bucket Spillway damaged
- Repaired using gabion but re-eroded
- Outlet valve vibration issue and hydropower outage -> more pressure on spillway
- <https://www.youtube.com/watch?v=4yOXpSxyWN>
U

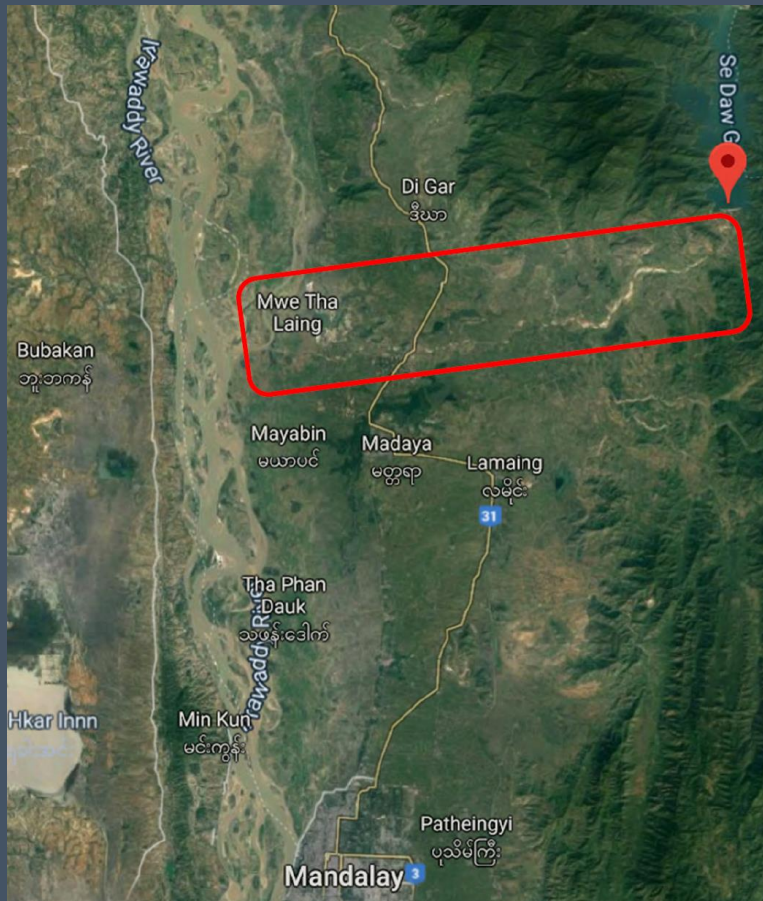
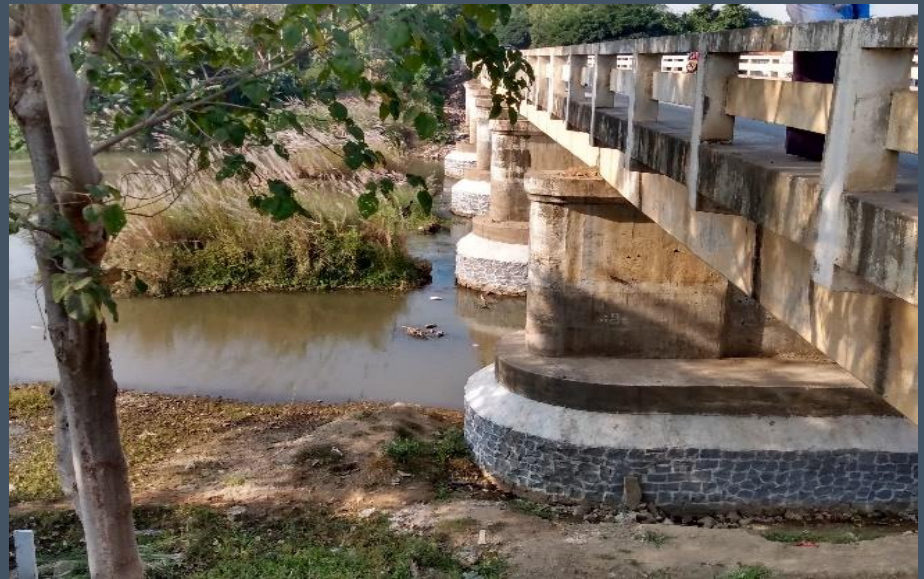
Sedagwi Channel

- Operations
- Downstream flood
- Gate malfunction

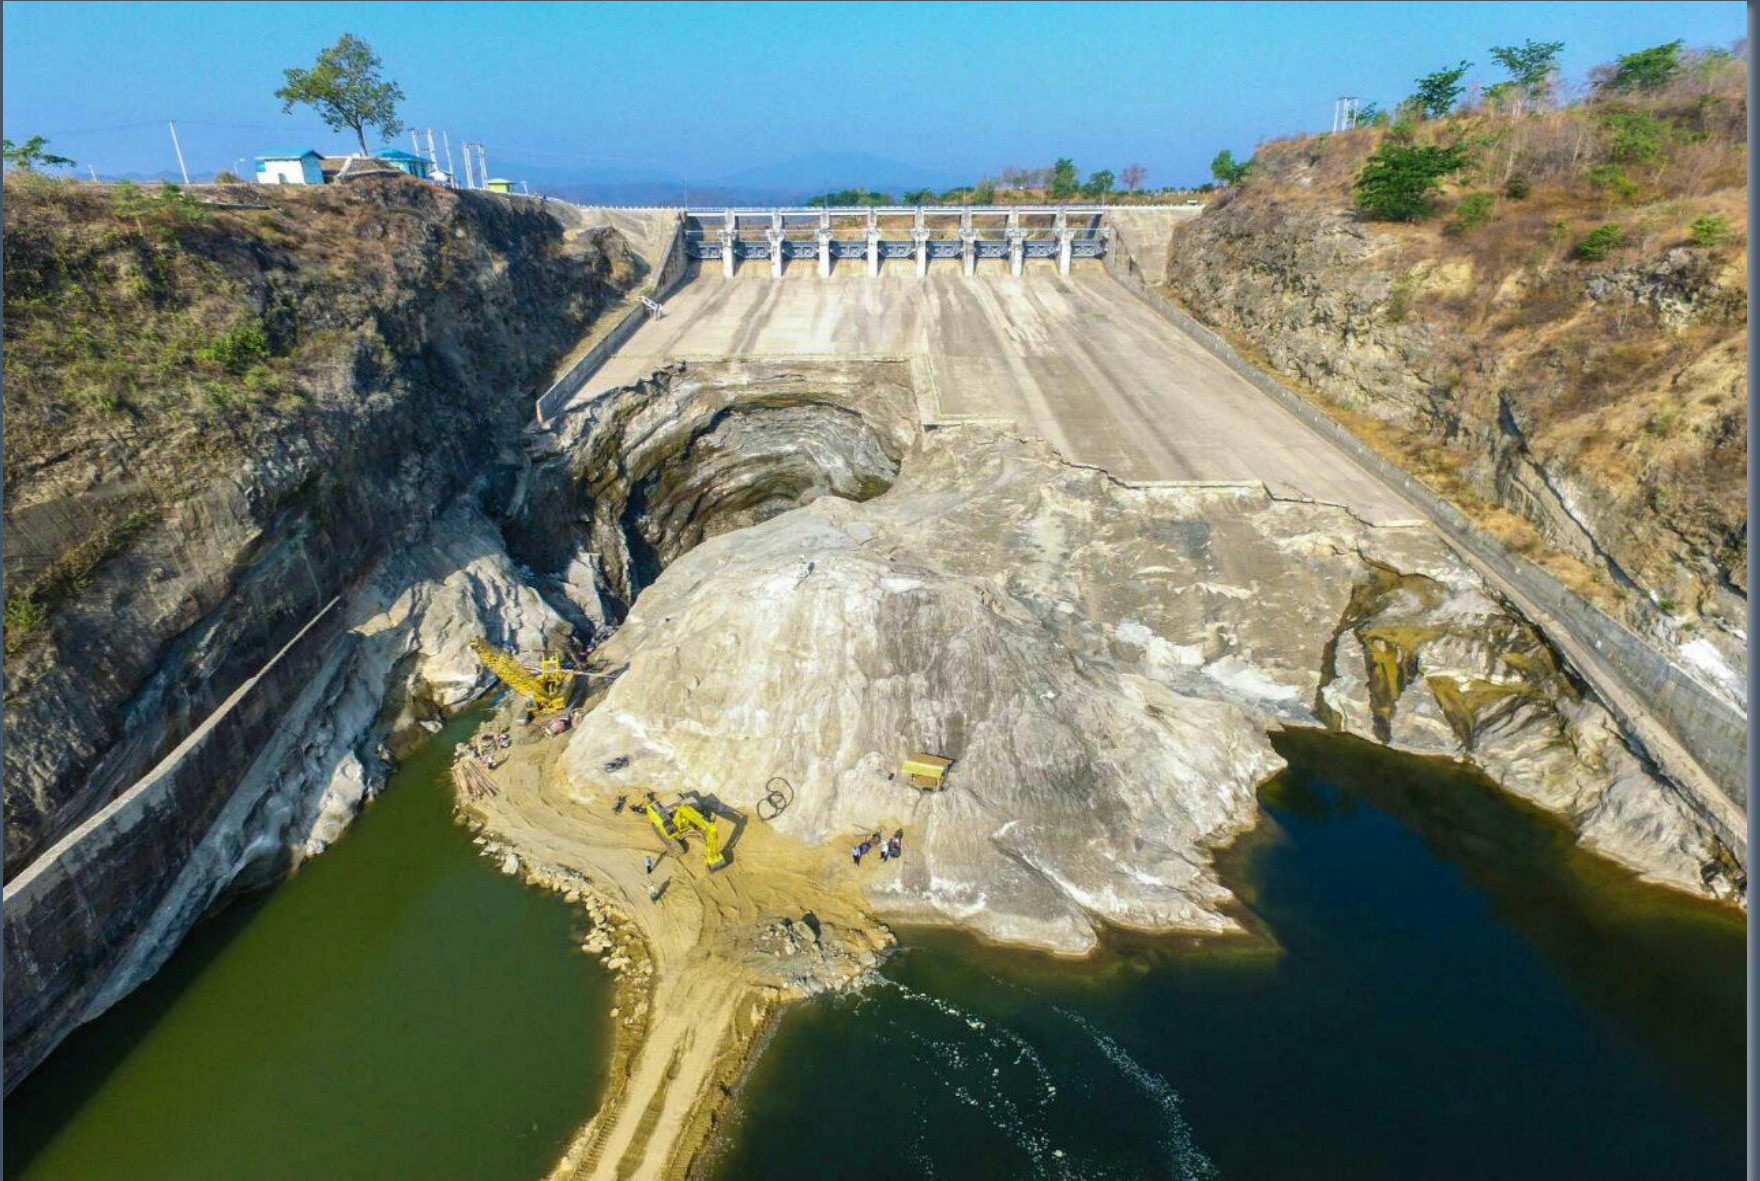
Kyee-on Kyee-wa

- Spillway capacity
- Erosion
- Gates create backwater downstream of Mone
