Citywide Inclusive Sanitation in Vanuatu

Hilson Toaliu

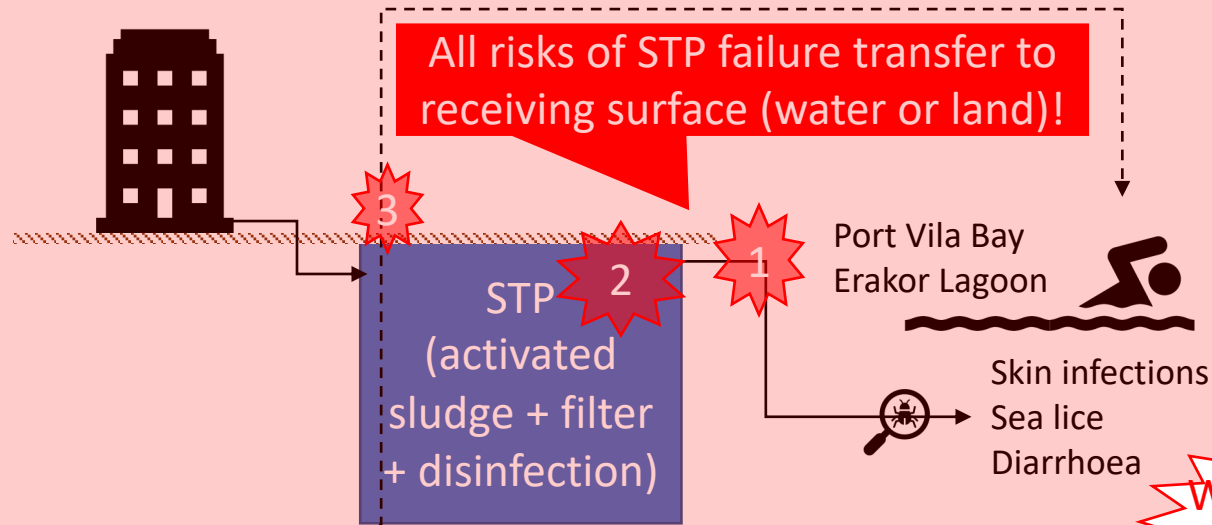
Highest Risk: 3 STPs (discharge to open)

- Central Hospital (200 beds)
- Iririki Resort (139 rooms)
- Grand Hotel (74 rooms)

1. Likelihood of effluent failure (to outfall)
 - All STPs failing although Grand Hotel tests effluent monthly
2. Likelihood of STP failure (to outfall)
 - All STPs failing although Grand Hotel has a maintenance contract
3. Likelihood of sludge failure (to outfall)
 - Iririki & Central Hospital have sludge drying beds that have failed

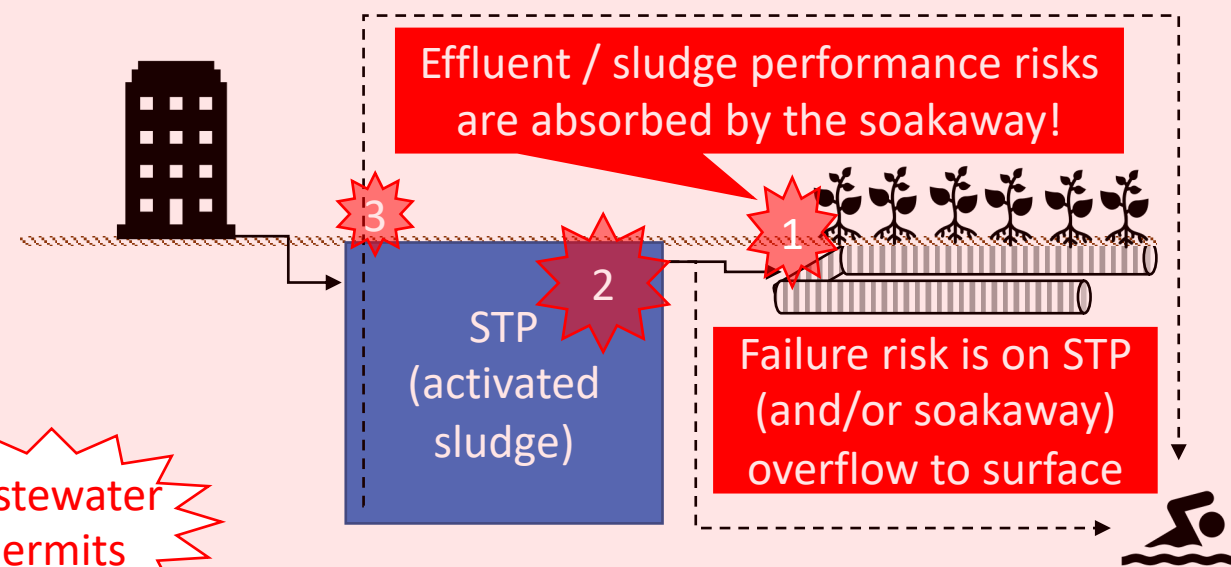
High Risk: 12 STPs (discharge to soakaway)

- Market House, Bred Bank, Reserve Bank, Holiday Inn
Mama Handicraft, Children's playground, Lapetasi Wharf, Ramada, Tanna Russet
Warwick Le-Lagon, University of South Pacific, Vanuatu Club, Airport

1. Likelihood of effluent failure (soakaway overflow to surface)
 - All STPs at risk. Warwick Le-lagon, USP, Airport, Vanuatu Club failed
2. Likelihood of STP failure (bypassing of soakaway to surface)
 - Mama handicraft, Children's playground, Ramada, Tanna Russet failed
3. Likelihood of sludge failure (on backing-up of system)
 - All STPs at risk. Market House has sludge thickening

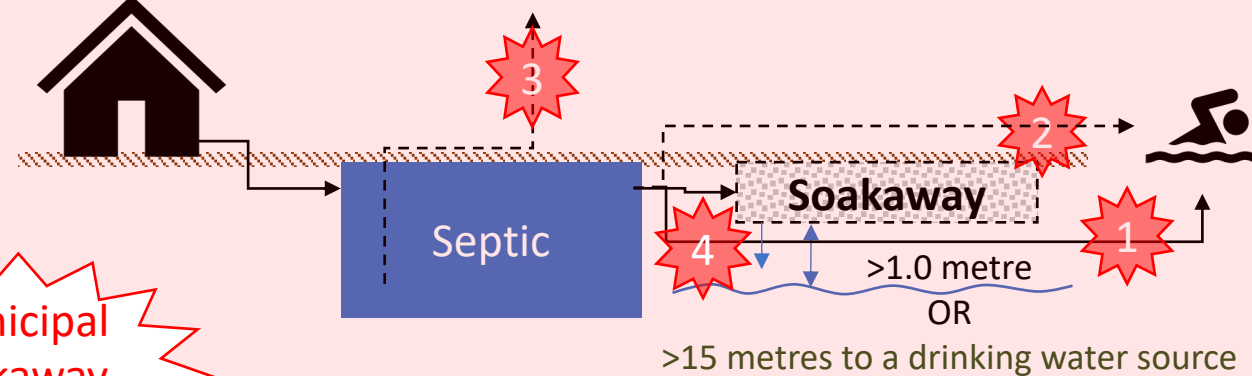
Separate Soakaway

Required for sandy soil & ground water table <3 metres deep
